MTL TR 90-44

FAILURE ANALYSIS OF A MAIN ROTOR PITCH HORN BOLT LOCATED ON THE AH-1 COBRA HELICOPTER

VICTOR K. CHAMPAGNE, Jr.
MATERIALS TESTING AND EVALUATION BRANCH

September 1990

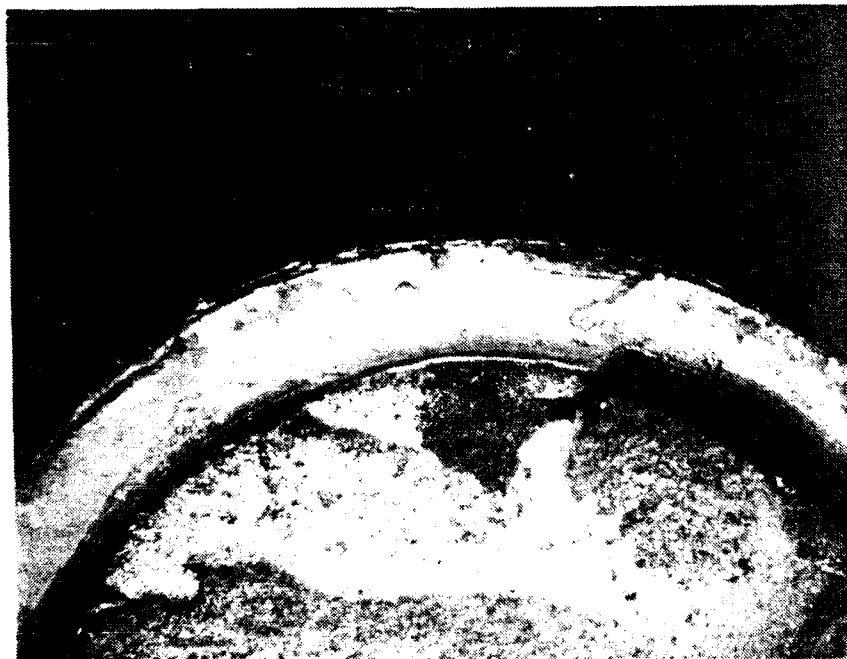
Figure 8. Optical macrograph showing the damaged cadmium plating and evidence of corrosion on the fracture face. MAG. 15X.

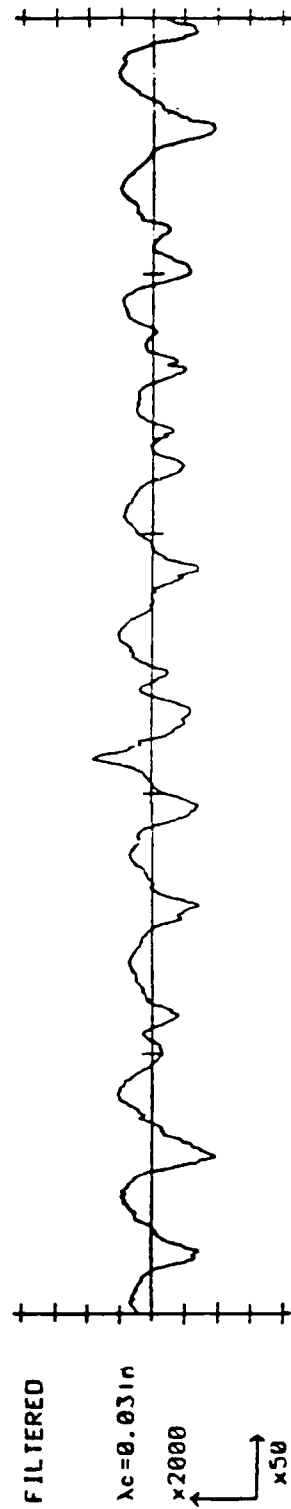
Figure 14. Topography traversed by profilometer on Area 1 (refer to Table 1). The RMS roughness value obtained was 68 microinches.

Surface	Roughness (RMS) (u in.)
Area 1	68
Area 2	64
Area 3	70

3. A Mitutoyo Surftest Analyzer was used to measure the surface finish along the upper bolt shank in three locations. The results showed that the surface profile was within the specified range.

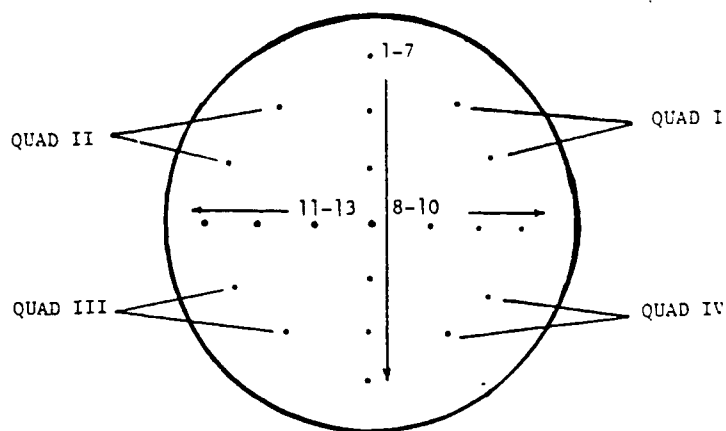
Figure 16. Shows the transverse cross section of the bolt and locations where hardness measurements were taken.

Bolt No. 3	
No. of Readings	HRC Values
1	42.6
2	43.8
3	44.0
4	44.1
5	44.1
6	43.3
7	43.6
8	44.0
9	44.0
10	43.3
11	44.3
12	43.8
13	42.1
Quad I	43.5 43.7
Quad II	43.3 43.8
Quad III	44.0 44.1
Quad IV	43.9 43.9
Avg.	43.7
S.D.	0.54

5. Hardness measurements taken on transverse cross sections of the bolt adjacent to the fracture indicated that the material was hardened to the upper limit of the acceptable range as designated on the engineering drawing.

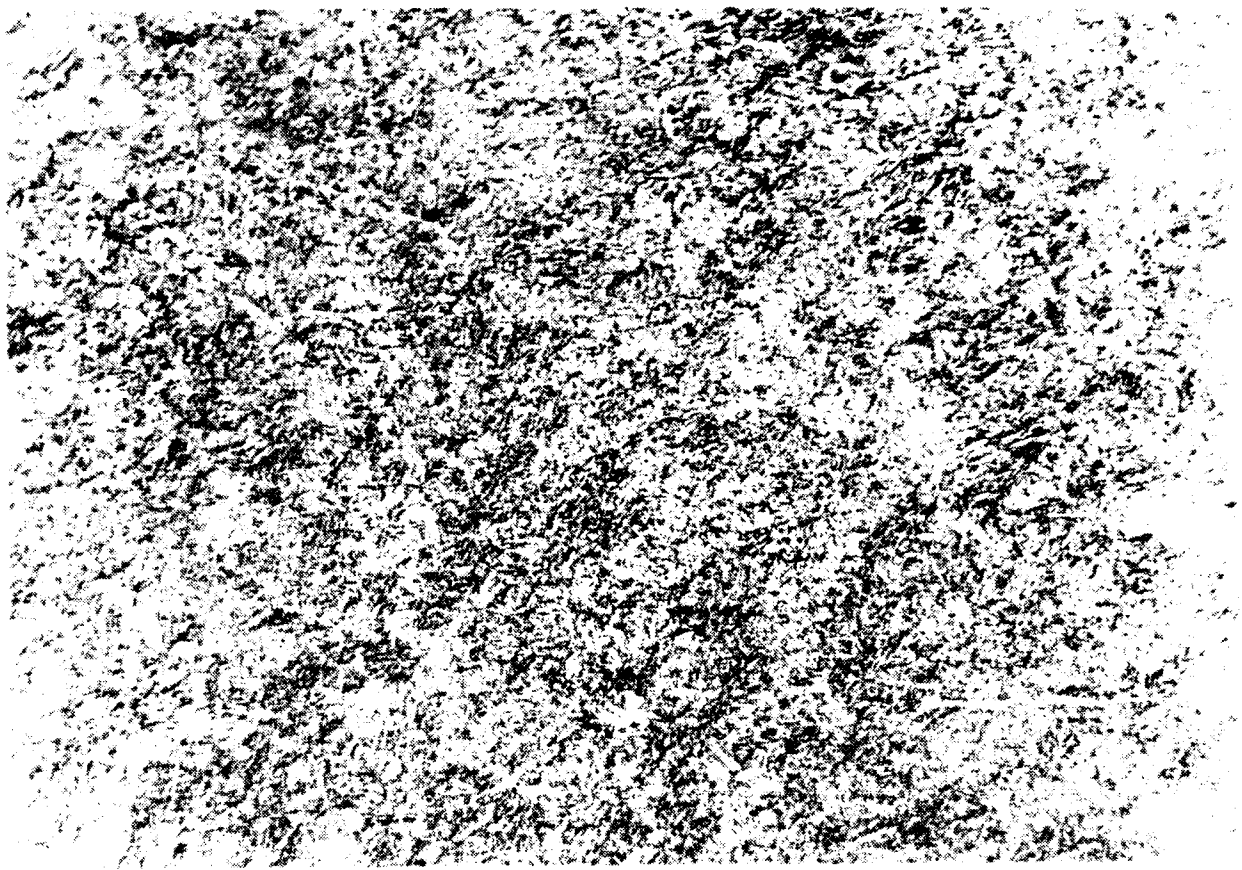
A transverse cross section of the bolt was taken adjacent to the failure and prepared for metallographic examination. A 1% Nital etchant revealed a typical tempered martensitic structure, as shown in Figure 17. Close examination of the microstructure near the crack initiation site and areas near the fracture were conducted in order to detect any possible structural changes that may have occurred during fabrication or in service. There were no signs of structural changes or any regions that contained unusual precipitation or coagulation of carbides. In addition, the material was relatively "clean" having no large inclusions or inherent material defects.

Figure 17. Shows the representative microstructure of the bolt which was tempered martensite. MAG. 500X.

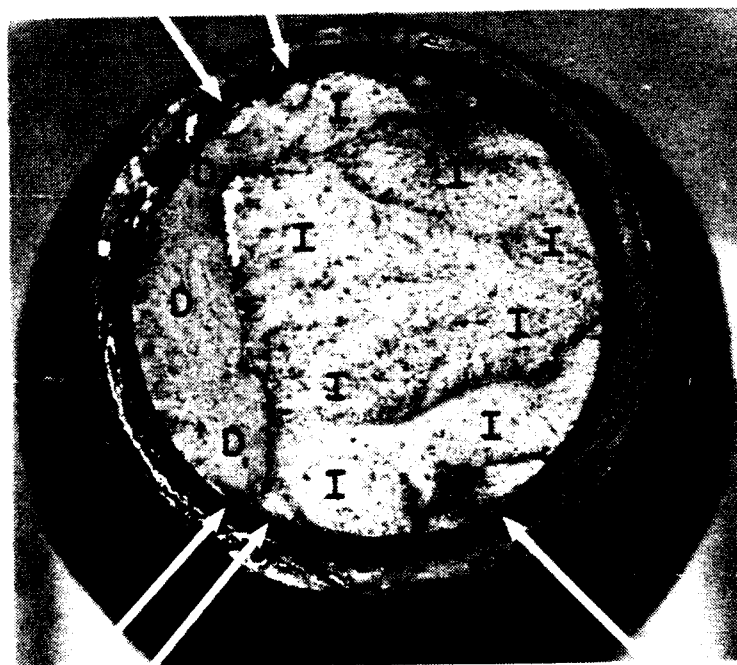
The pitch horn bolt sheared completely in half below the conical section at the threaded portion of the component while in service. Since the threaded section below the fracture which contained the nut was missing upon disassembly, only one fracture face could be examined. The scanning electron microscope (SEM) was utilized to identify the failure mode in each fracture zone identified in Figure 19. An enlargement of the fracture surface of the bolt is contained in Figure 20. Figure 19 was taken with an optical microscope, while Figure 20 is a SEM macrograph provided for comparative purposes. In many instances certain macroscopic features of the fracture are highlighted better with reflective light, such as corrosion. The cadmium plating circumventing the fracture was blistered and worn away entirely in numerous locations exposing a bare metal surface to the environment. This condition is ideal for Stress Corrosion Cracking (SCC) to occur. The arrows in both fractographs identify crack origins. These areas assumed a geometry indicative of a "thumbnail" crack, so-called because of their resemblance to a human thumbnail. The fracture path was complex and not easily discernable. The material did not exhibit much plasticity during fracture which was anticipated from an embrittlement type failure. There were also several regions darkened by corrosion that are more readily visible in Figure 19. Multiple crack origin sites are a common feature associated with SCC, whereas a failure attributed to Hydrogen Embrittlement, in which hydrogen had diffused into the material during electroplating would normally consist of a single large crack. In addition, HE fracture surfaces tend to be free of heavy oxides and corrosion in contrast to surfaces which are the result of SCC because, in the latter case, these failures are environmentally induced.

Figure 19. Optical macrograph of the fracture surface showing the various crack propagation zones. MAG. 7.5X.

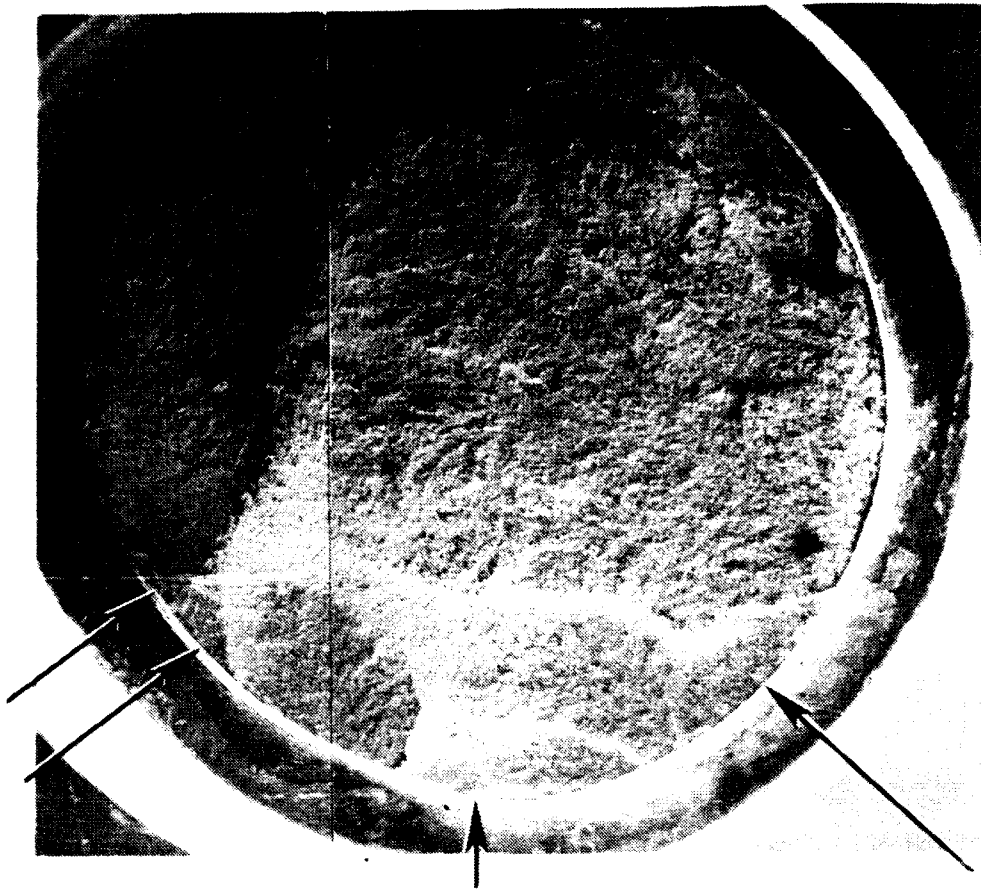
Figure 20. SEM fractograph comparing macroscopic features of the surface with those of Figure 19. MAG. 10X.

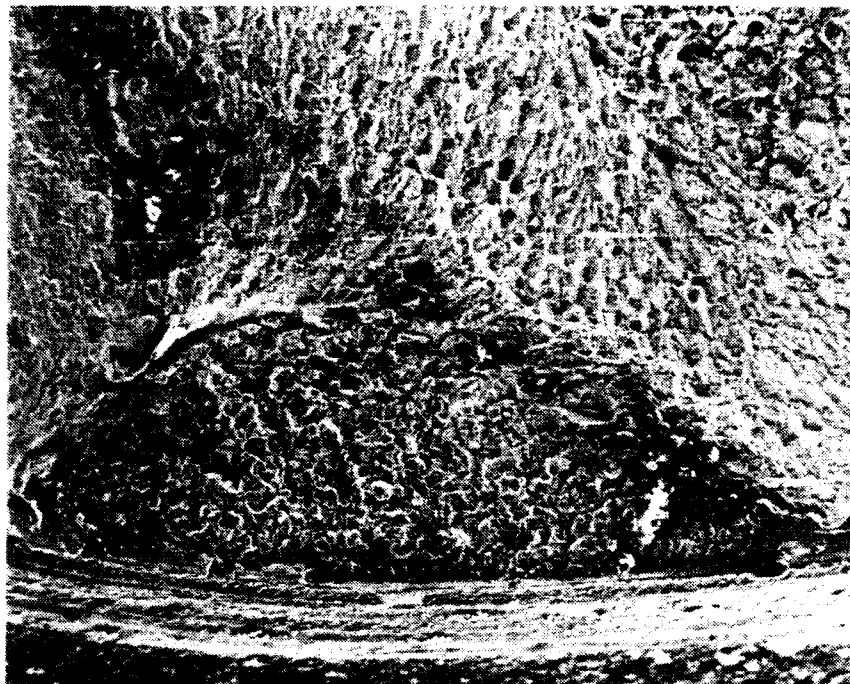
Figure 21 shows one of the "thumbnail" cracks covered with a dark layer of corrosion making it highly distinguishable. The shape of this type of fracture usually suggests a single point crack origin, such as a surface defect or machining mark. The failure did occur at the machined radius which was a stress concentration area, but more significantly, corrosion pits most likely initiated the cracks, as shown in Figure 22. The morphology within the "thumbnail" crack was different than the surrounding fracture surface. Closer examination revealed that the failure mode within this region was intergranular, as shown in Figure 23, with some evidence of secondary cracking. SCC fractures in high-strength, quench, and tempered 4340 steel occur primarily by intergranular decohesion. The areas beyond the "thumbnail" cracks exhibited a mixed topography of ductile dimples, as shown in Figure 24, and also intergranular cracking before the onset of final fast fracture. Figure 25 contains the transitional zone of a crack which progressed from an intergranular mode of failure to one of ductility.

Figure 21. SEM containing a "thumbnail" crack. MAG. 75X.

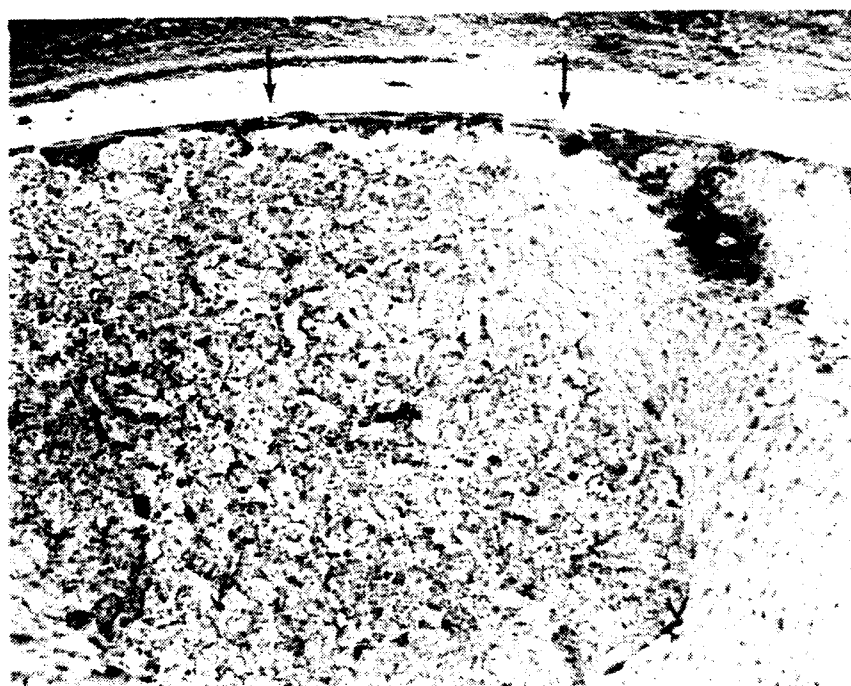
Figure 22. SEM showing corrosion pits adjacent to the fracture (designated by the arrows). MAG. 50X.

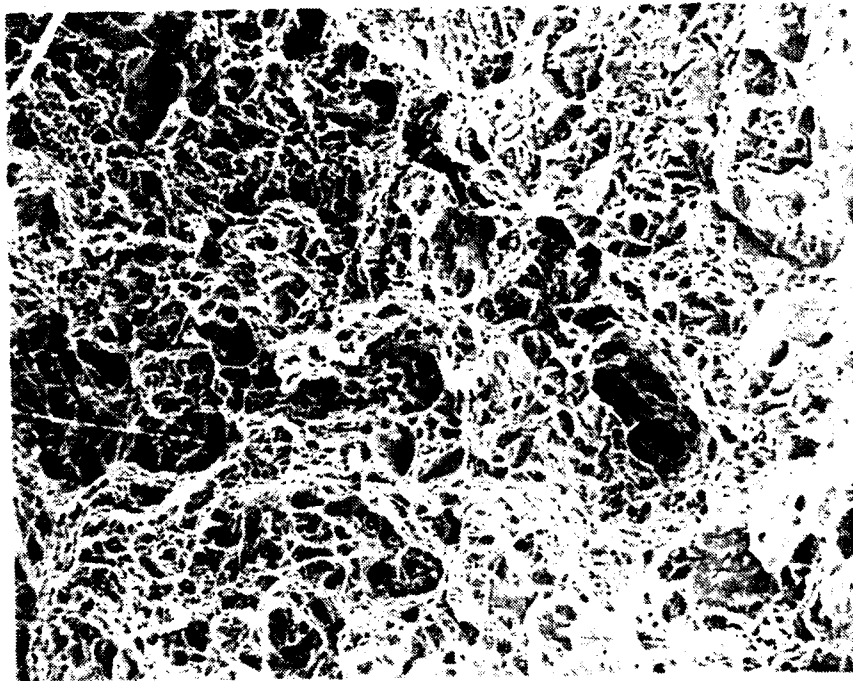
Figure 24. SEM representative of the fast fracture zones with a predominantly ductile dimpled surface morphology. MAG. 1KX

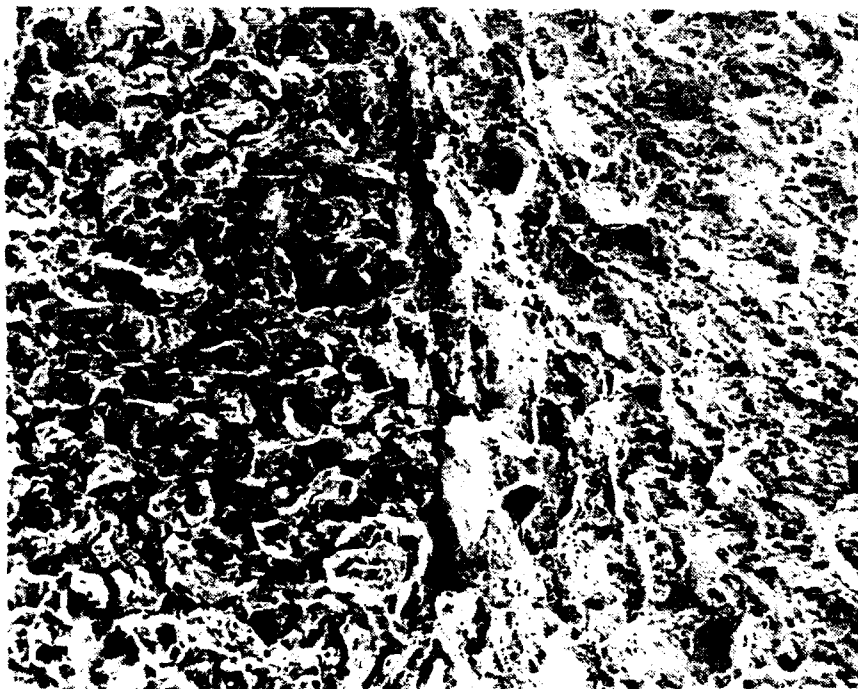
Figure 25 SEM of a failure mode transition from intergranular to ductile dimples. MAG. 200X

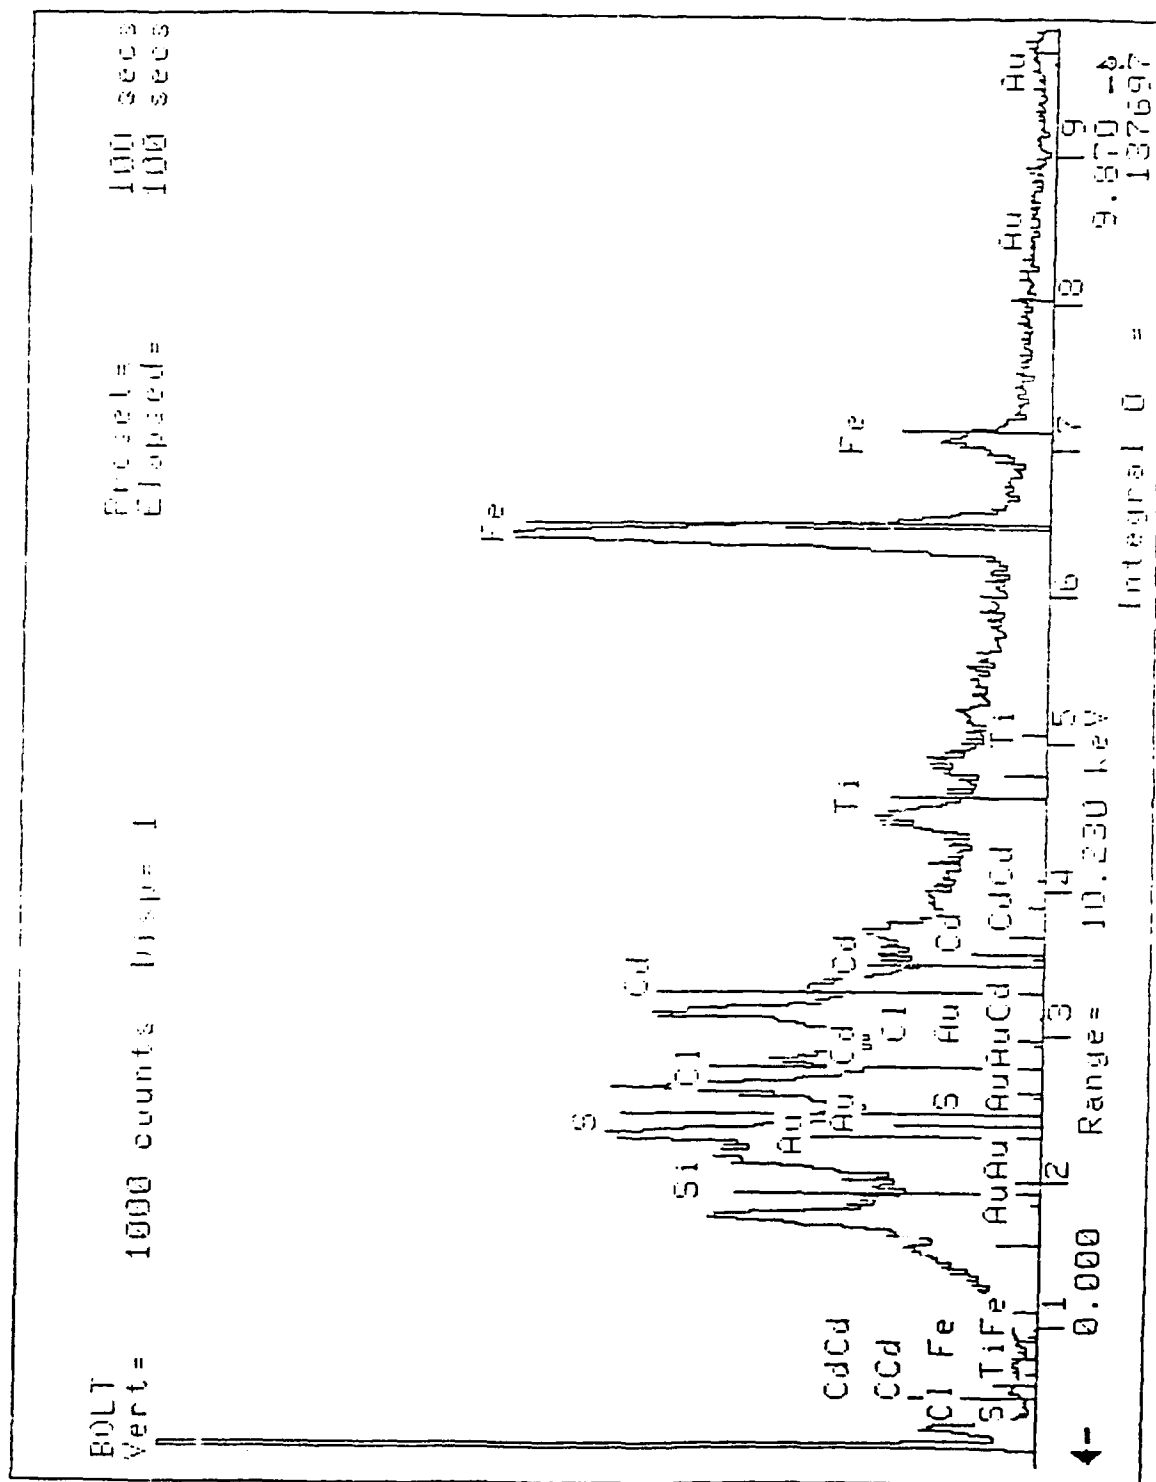
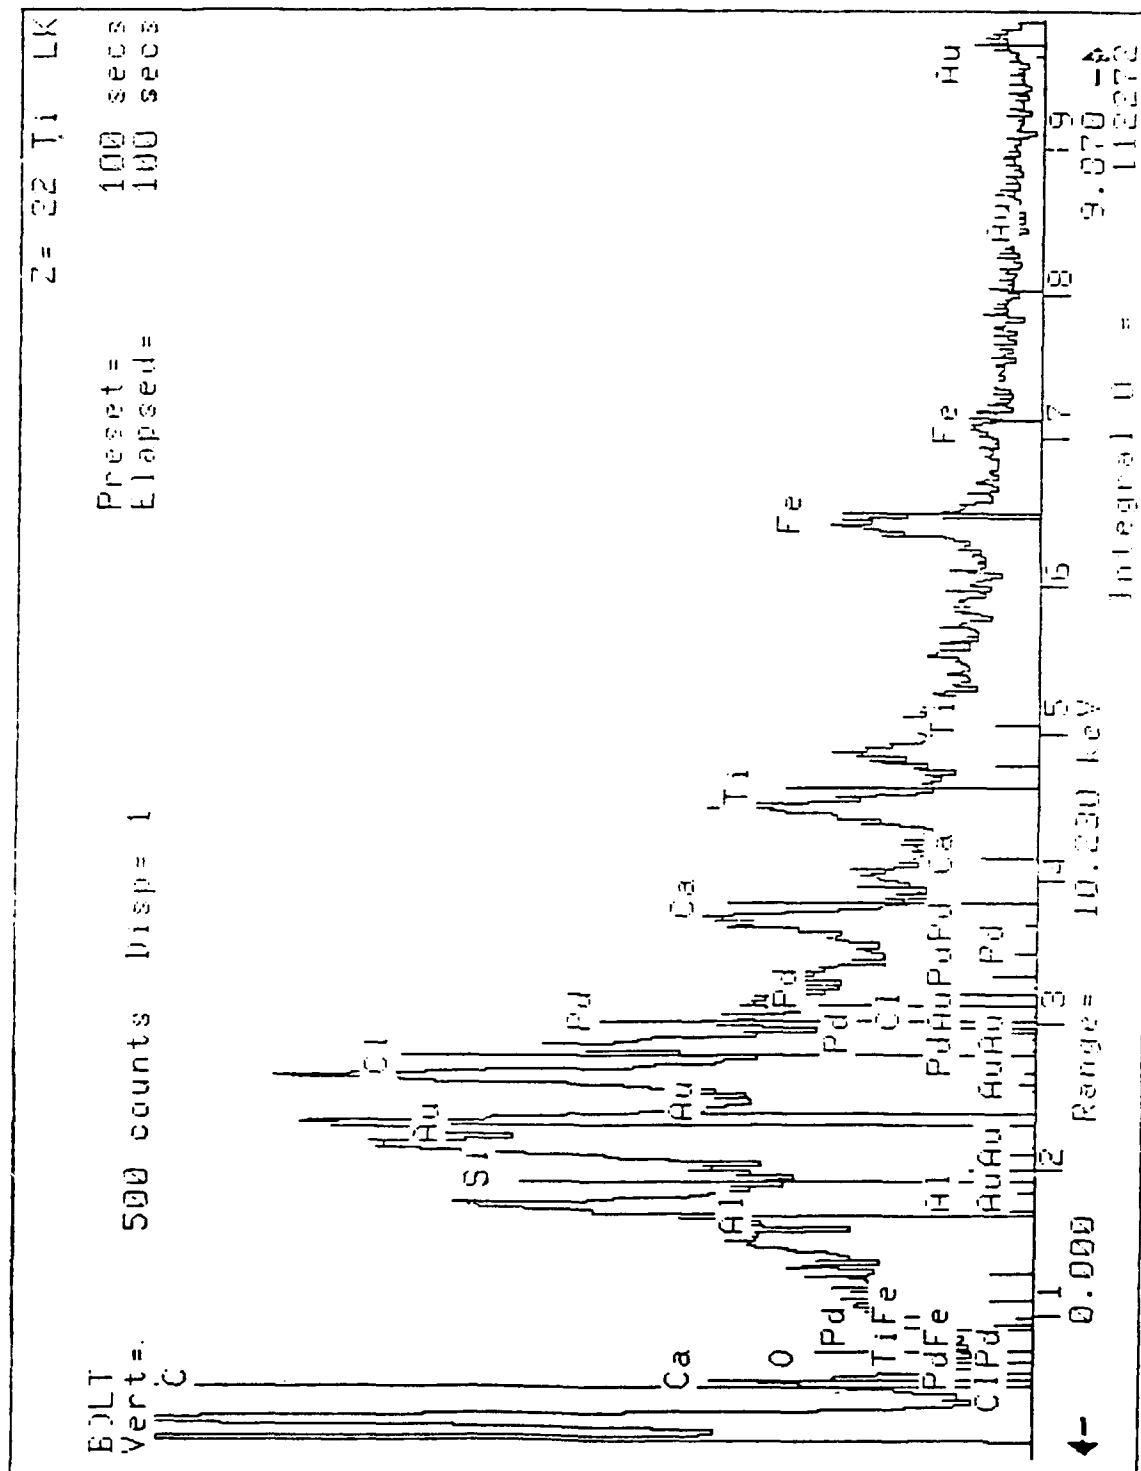
Energy dispersive spectroscopy (EDS) was utilized to characterize the composition of the dark corrosion layer which covered the "thumbnail" cracks. Figures 26 and 27 reveal the spectra of these regions which consisted of those elements associated with the type of steel under investigation, such as Fe, S, and Si, as well as oxygen which is indicative of a corrosion product. The Cd peaks represent traces of the cadmium plating while C and Ca may be attributed to surface oils, lubricants, or greases. Au and Pd were present because the fracture surface of the bolt had been sputtered with a fine layer of these elements for examination purposes under the SEM. Titanium dioxide is commonly used as a coloring agent in paint pigment and also exists in some lubricants. The most significant finding was that of Cl which may be found in large concentrations as a result of pitting or crevice corrosion. The environment within a pit or crevice becomes acidic with time and the pH value can decrease to approximately 1.5 to 1.0 while the pH of the bulk solution remains neutral. Since these forms of corrosion are autocatalytic in nature the degree of metal dissolution within these regions increases as does hydrogen evolution. This alteration of the bulk environment combined with internal or externally applied stress allows the formation of SCC.
